PHASE 1 STREAM GEOMORPHIC ASSESSMENT

Castleton River, Rutland County Vermont

Final Report

RUTLAND REGIONAL PLANNING COMMISSION

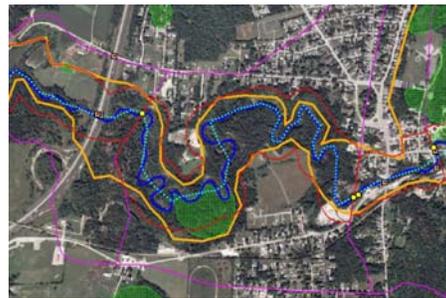
Figure 1: Reach number T02.02 depicting wetlands in green, main stem of the river in royal blue, thalweg in dotted cyan blue, subwatersheds in pink, river corridor in red, valley walls in orange, reach points as yellow dots and bridges as yellow squares.

The Castleton River Basin was divided into 54 reaches for the purposes of this study. Each reach is a like area studied as one geologic unit(Figure 1) The main stem of the Castleton River was divided into 17 reaches, the Gully Brook was divided into 5 reaches, North Breton Brook was divided into 8 reaches, Pond Hill Brook was divided into 5 reaches, Belgo Brook was divided

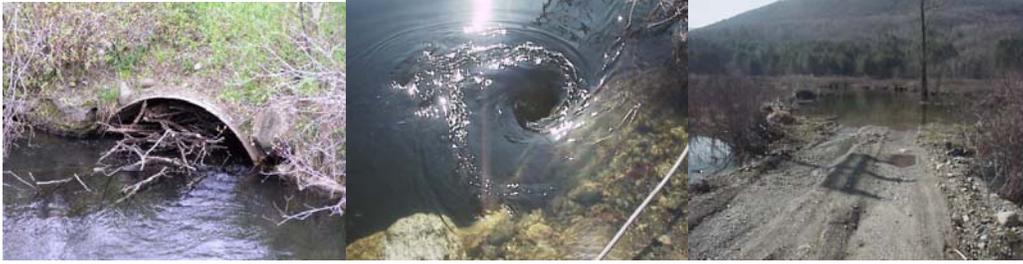
Bridges and culverts seem to be the modifications effecting the river most. 19 reaches have no bridges or culverts, leaving 35 reaches with at least one bridge or culvert. Of particular interest is a 48 inch culvert on the main stem of the Castleton River on reach T02.12 which is completely filled in with woody debris and forces the river out of its banks. See Figure 2.

Figure 2: *Culvert blocked with woody debris, whirlpool caused by overflow, flooded roadway on the main stem of the Castleton River, reach T02.12.*

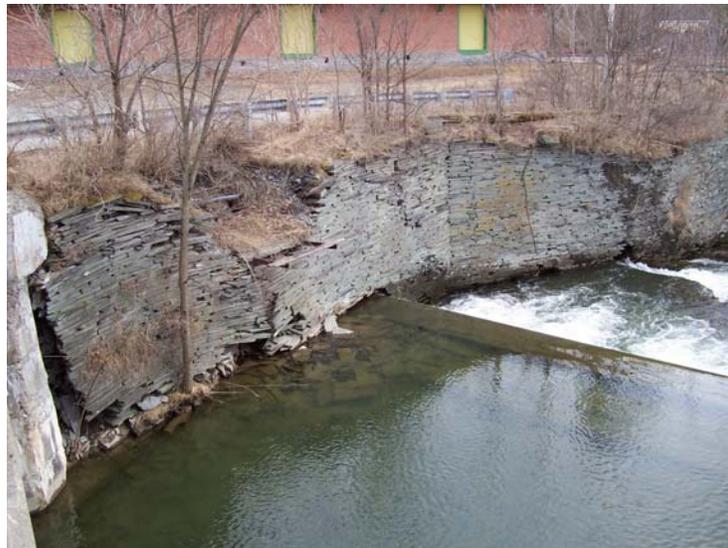
Bank armoring is present in 5 reaches with approximately 0.7 % of the total river length armored. Reach T02.03 in the town of Fair Haven is heavily armored with slate. See Figure 3.

Figure 3: *Bank armoring along the main stem of the Castleton River, reach T02.03*

Over the years, there have been many attempts at bank stabilization. Most of this occurs in the more urban areas as an effort to alleviate damage to structures, infrastructure and transportation systems. Rip-rap seems to be a common practice as it exists in several reaches, thus confining the river to its banks. There has been significant development along many of the Western reaches of the Castleton River.

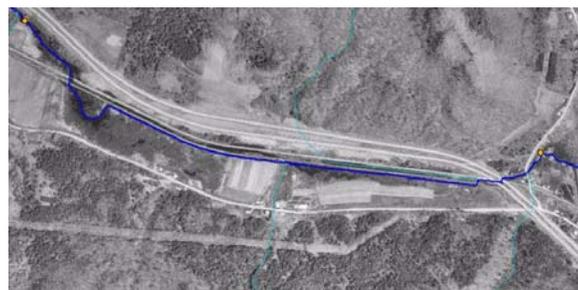
Impacts from channel straightening effect 20 reaches with approximately 14.5 % of the total river length straightened. See Figure 4.

Figure 4: *Channel straightening on the Castleton River, reach T02.13. This reach also shows modifications to the floodplain, including roads, rail and some development.*

Changes in the floodplain can also affect the river and its natural processes. Development in the floodplain alters the ability of the river to react to changes in the overall system. Houses, roads, rail and berms are the predominant floodplain modifications found in the Castleton River Basin. See Figure 4. 14 reaches have a high impact score relating to roads and berms while 10 reaches scored high due to development.

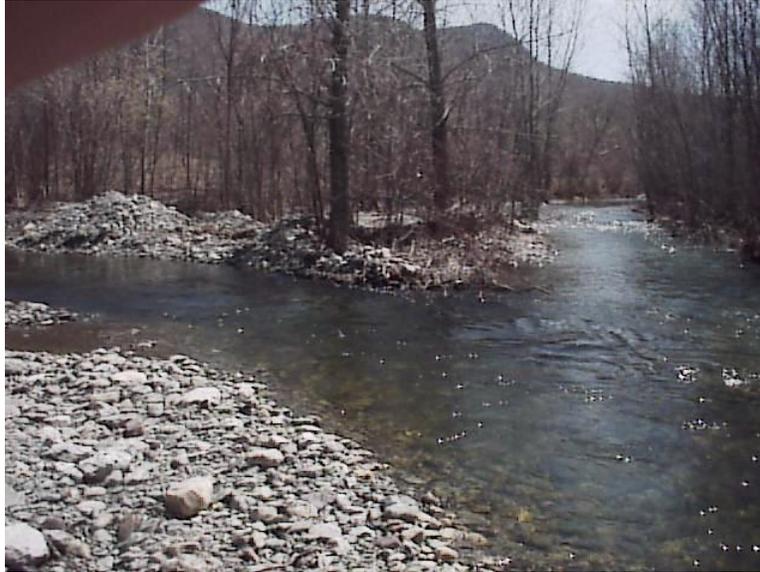
Gravel mining has occurred throughout history in numerous reaches along the main stem of the Castleton River. Today, gravel extraction is primarily performed by farmers abutting the river, few if any commercial operations exist. See Figure 5.

Figure 5: Gravel deposition at the confluence with Gully Brook, Castleton River reach T02.11.

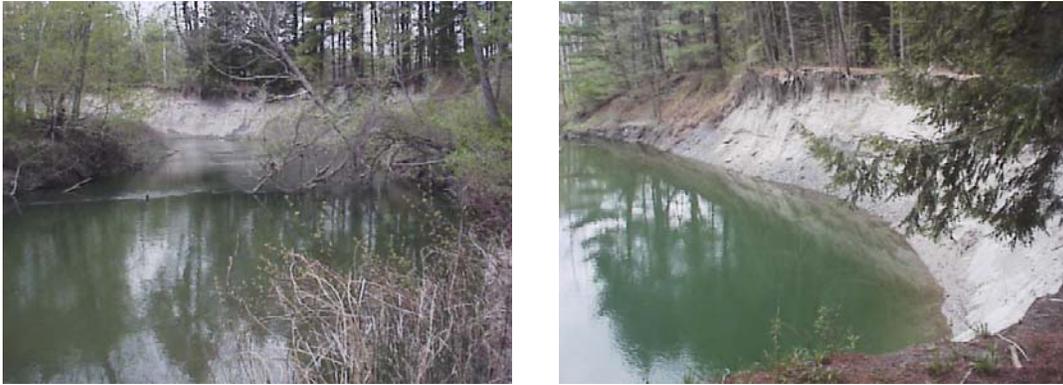
In addition, dominant bed form, bank height, bank erosion and ice jam potential were recorded in the windshield assessment. Based on bank data, 22 reaches(40.7%) had an impact of low, while 3 reaches(5.5%) had an impact of high and the remainder were not

Figure 6: Areas of steep high bank erosion, Castleton River, reach T02.02.

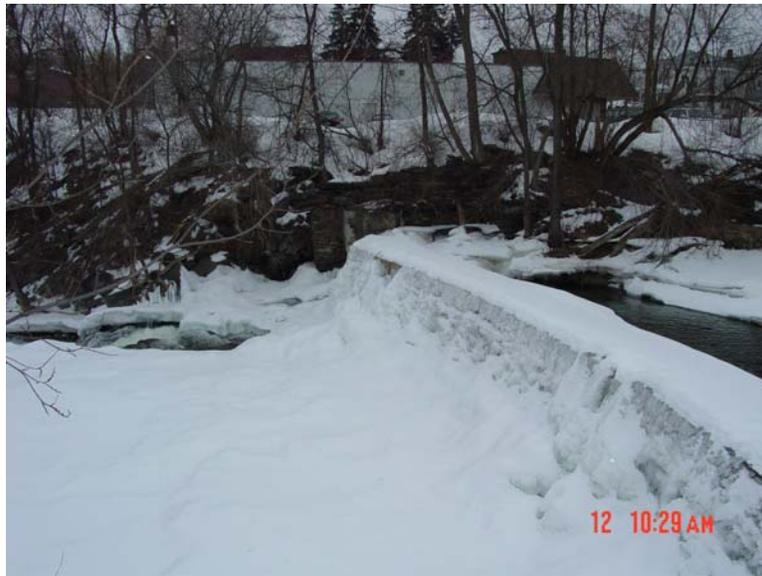
significant or not evaluated. Most ice jam potential is from undersized culverts and/or low bridges, although some potential for jams exists at sharp bends and tight constrictions in the river.

Figure 7 : Ice beginning to build up on the Castleton River, reach T02.03.
